**Preliminary Jurisdictional Determination
Of Waters of the U.S.**

**Lindale Economic Development Corporation
Approximately 135 Acres
Northwest Corner of I-20 at Harvey Road
Lindale, Texas**

ACEI Project No. 2007-300

January 18, 2008

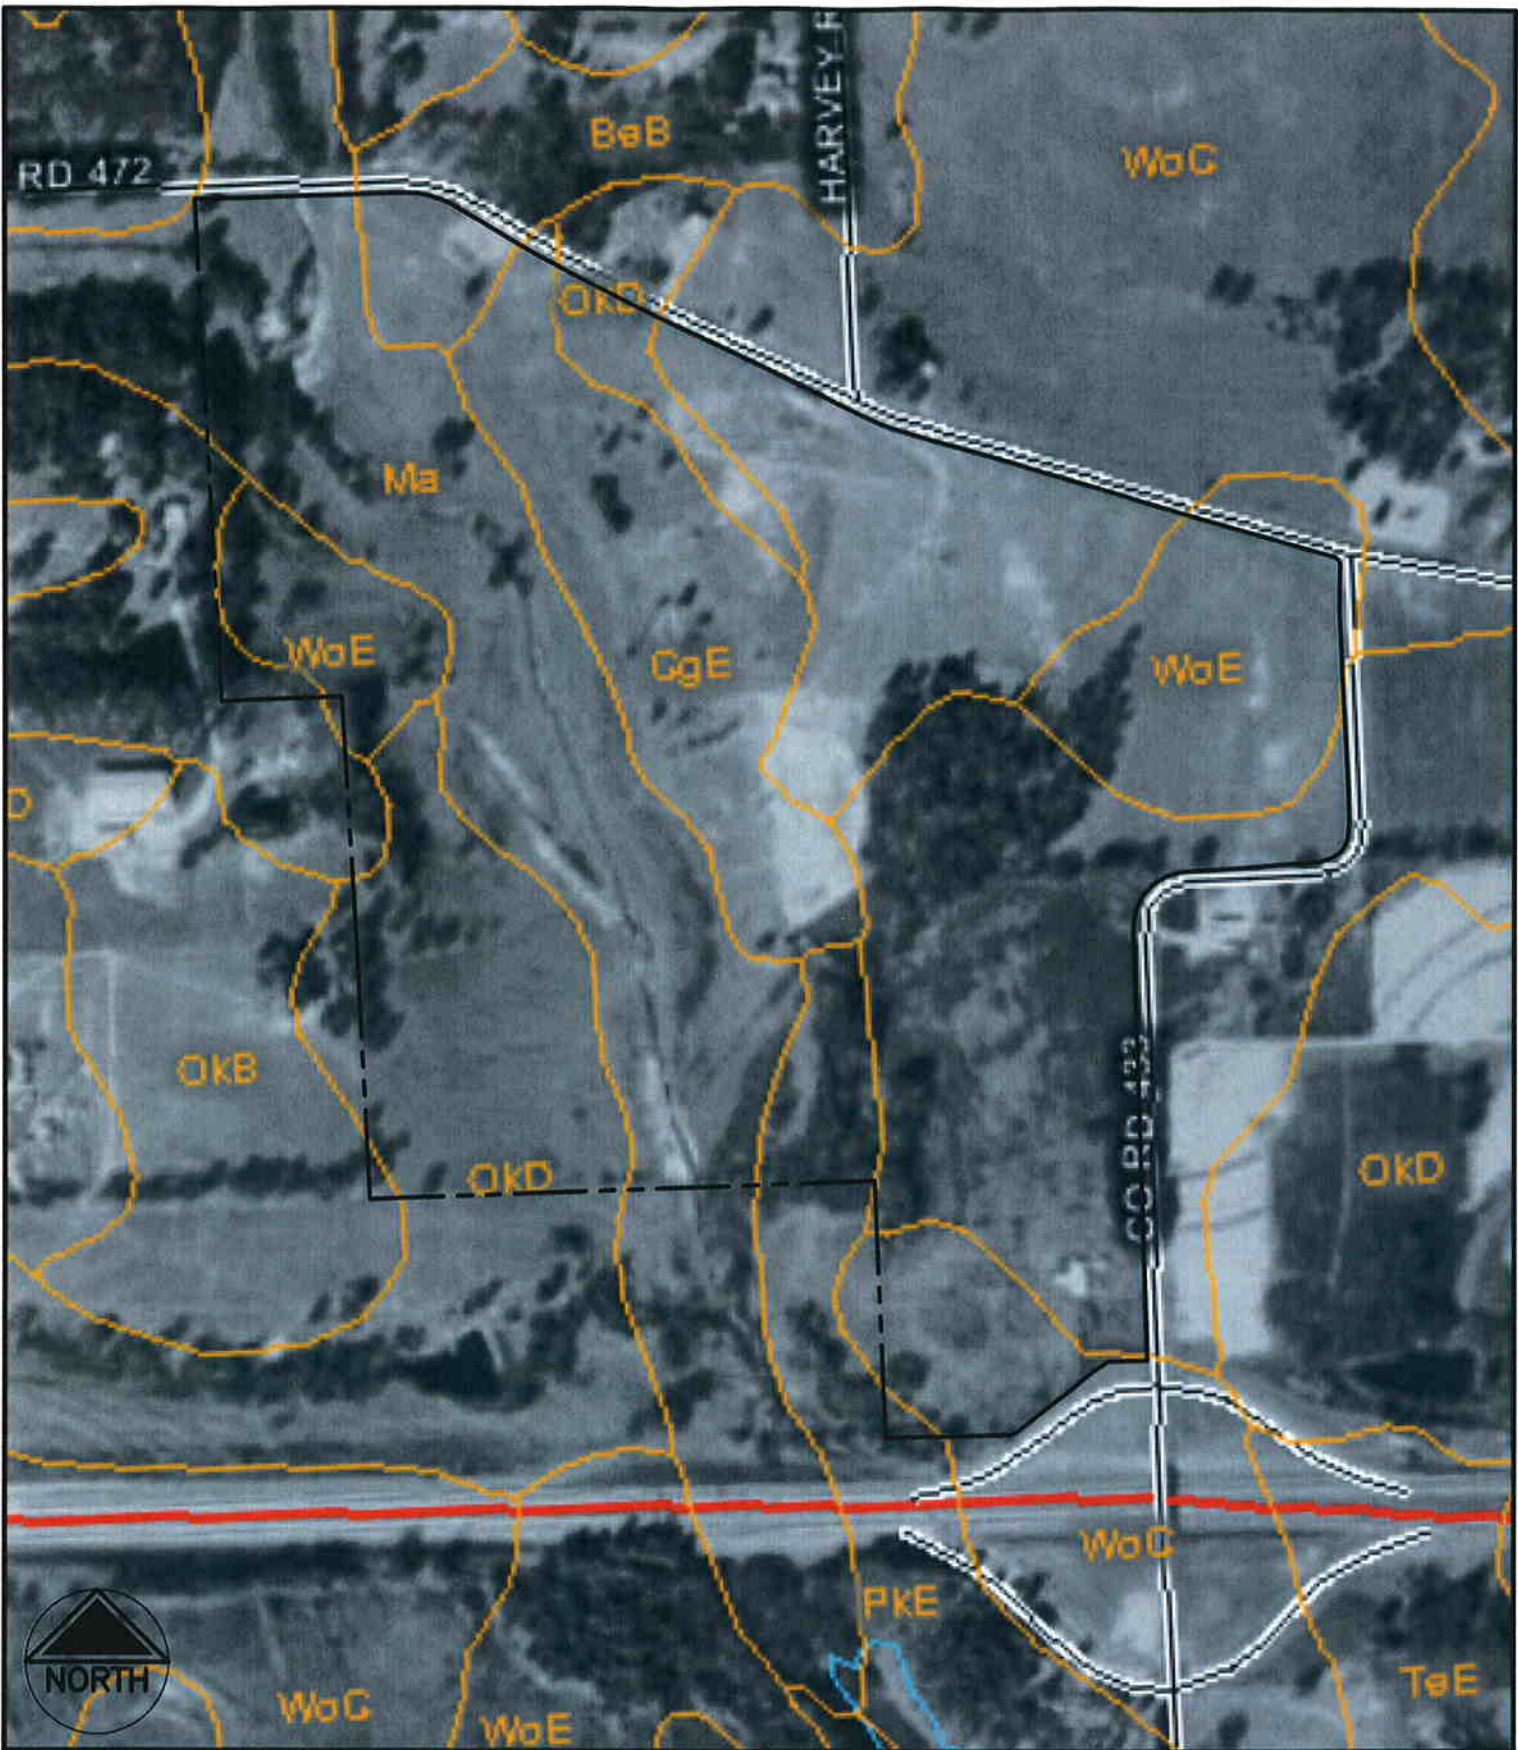
**NRCS SOIL SURVEY
MAP**

Prior to conducting the on-site inspection, a review of the United States Department of Agriculture (USDA) Soil Survey of Smith County, Texas was conducted. According to the soil survey, numerous soil series were mapped on the property. The wetlands were generally found within the Mantachie loam, frequently flooded soil series. An observation point established outside of the wetland boundary was located within the Pickton loamy fine sand, 8-15 percent slopes soil series.

The Mantachie loam, frequently flooded soil series is described as a soil on nearly level flood plains along the meander of streams. The soil is somewhat poorly drained, and is listed on the National Hydric soils list. The taxonomy of this soil is classified as Aeric Fluvaquents. The Pickton loamy fine sand, 8-15 percent slopes soils are described as strongly sloping or moderately steep soils on side slopes above drainageways, which is the character of the subject soil on the property. The soil is well drained and is not listed on the National Hydric Soils list. The Pickton soil taxonomy is described as Grossarenic Paleudalfs.
